Inspection Report Minerals Regulatory Program November 27, 2015

Mine Name: New Start Mine (formerly Freedom From War)	Permit Number: S/039/0024
Operator Name: Boyd Brothersen	Inspection Date: November 19, 2015
Inspector(s): Peter Brinton, McKay Tenney	Time: early afternoon
Other Participants: none	Mine Status: Reclamation (in progress)

Inspection Purpose: Evaluate reclamation as a basis for a partial bond release

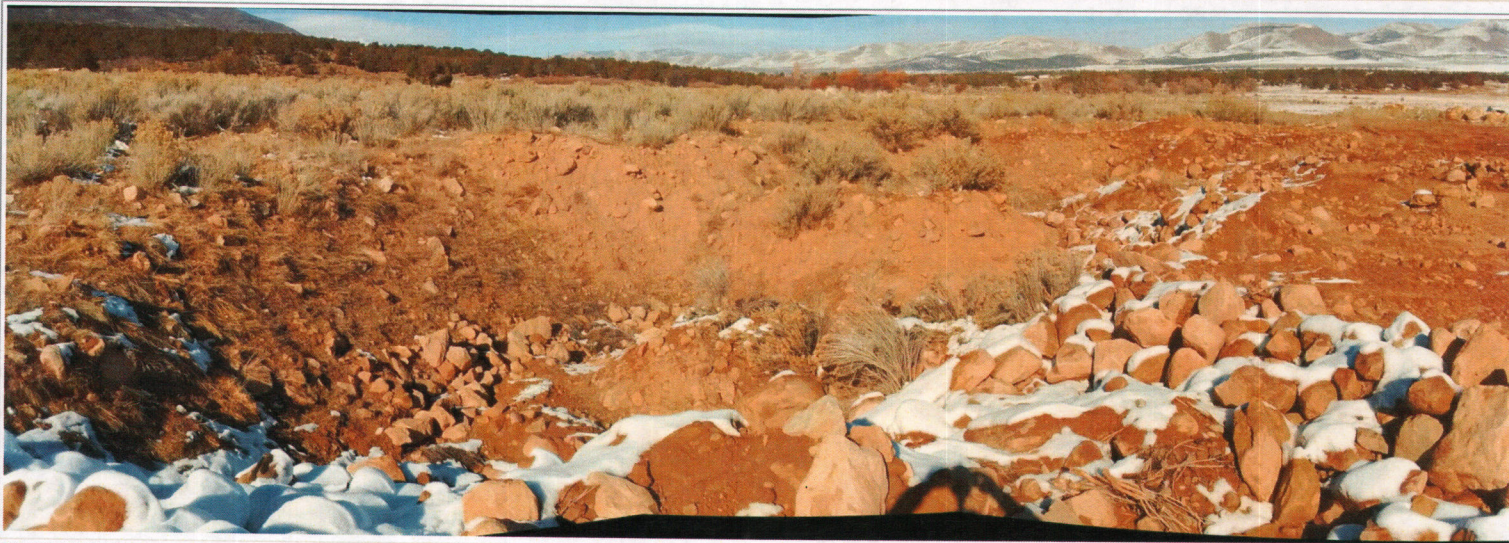
Remaining pit near equipment area where rock cleared from the surface is being pushed. Looking north. Stitched photo.

Conclusions and Recommendations: Regrading of all but about 0.75 acres is acceptable, and a partial surety release is recommended. Surety should be retained to cover grading of pits and pile disturbances and revegetation of graded areas that are not yet established. Knapweed control will be needed in 2015.

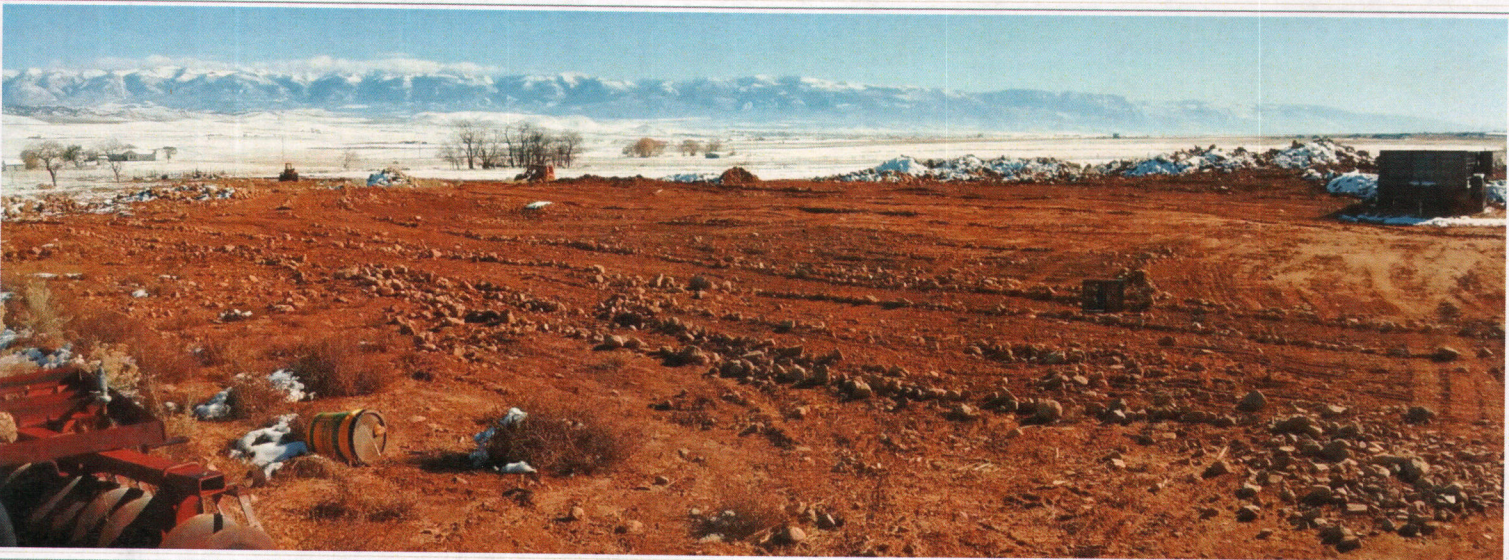
Graded area with rock removal, looking southeast. Note remaining snow-covered piles in middle background to the right and the left. Stitched photo.

Some revegetated areas were released in the 2015 permit transfer and Notice amendment. As of this inspection, recently regraded areas had not yet been seeded, and it is recommended that the surface either be drill seeded or roughened and immediately (or concurrently) broadcasted. Seed tags and a revegetation work summary should be sent to the Division. Considering knapweed growth on disturbed and undisturbed areas, weed control will continue to be needed until beneficial vegetation is established on regraded acres. Mr. Brothersen has reported personal and county efforts to spray knapweed. Photos were taken to document conditions.
